**Subject:** MTM Solenoid Fault Codes and Vehicle Air System Contamination – Endurant HD, XD and PACCAR TX-12, TX-18

**Document Number:** TAIB-1006

**Date:** April 6, 2023

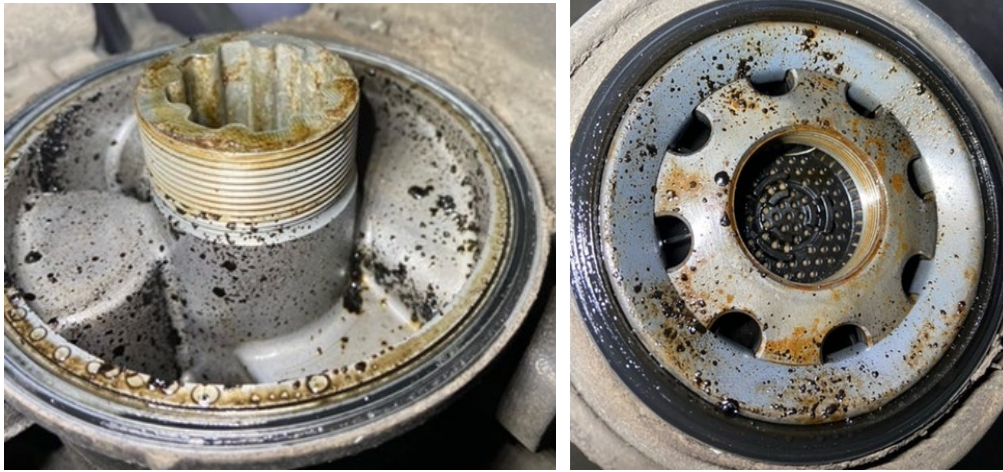
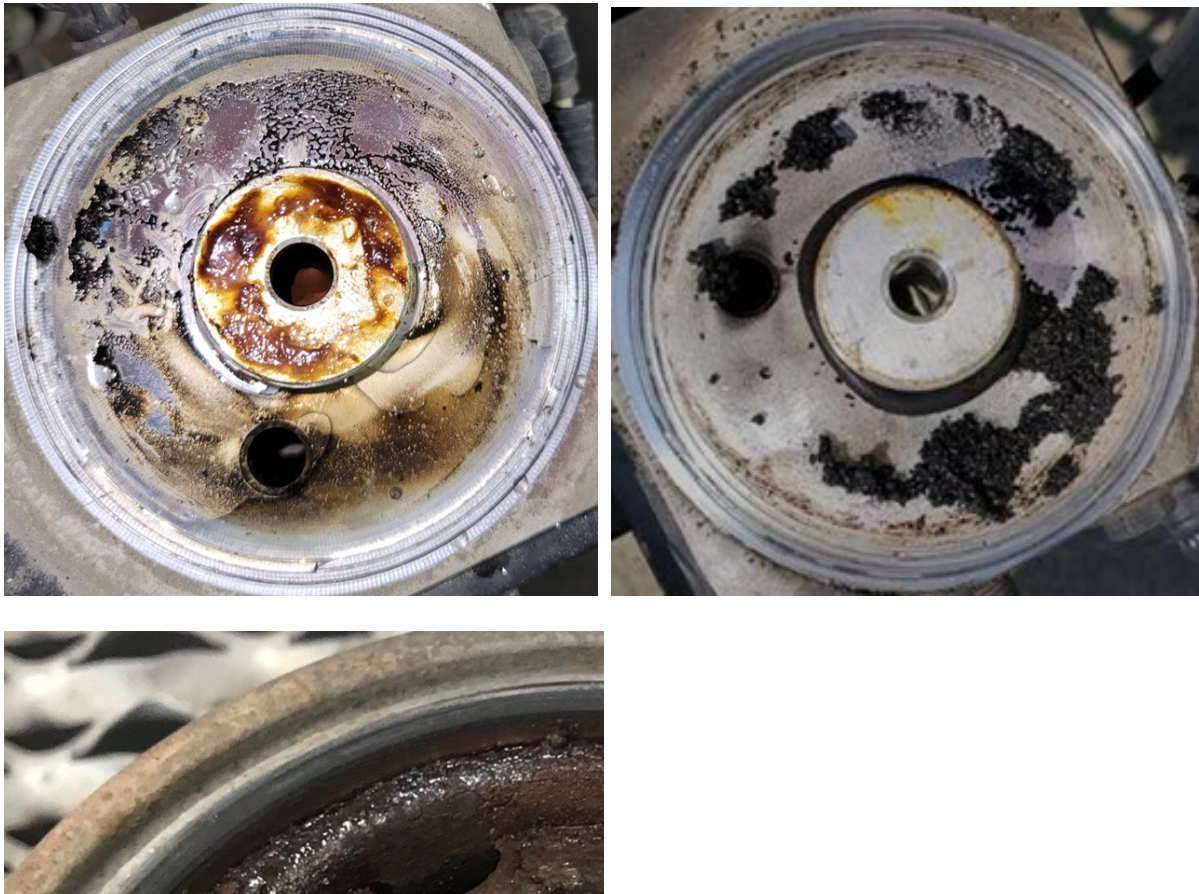
**Air Dryer Cartridge:**  
**Contamination indicated:**

7. Refer to OEM and/or air system manufacturer guidelines and remove vehicle air system Air Dryer Cartridge.
8. Inspect and record condition of the cartridge and mounting surface for oil and/or debris and compare to **Air Dryer Cartridge** images below.

**Air Dryer Cartridge (continued):**  
**Contamination indicated:**

**\*NOTICE:** Eaton Cummins Automated Transmission Technologies recommends inspection and repair of the vehicle air system to correct the source of contamination. Refer to OEM and/or vehicle air system manufacturer maintenance guidelines to ensure proper air system operation, i.e., drain water from air tanks, replace air system filters and cartridges. Refer to [Vehicle Maintenance Recommendations](#).

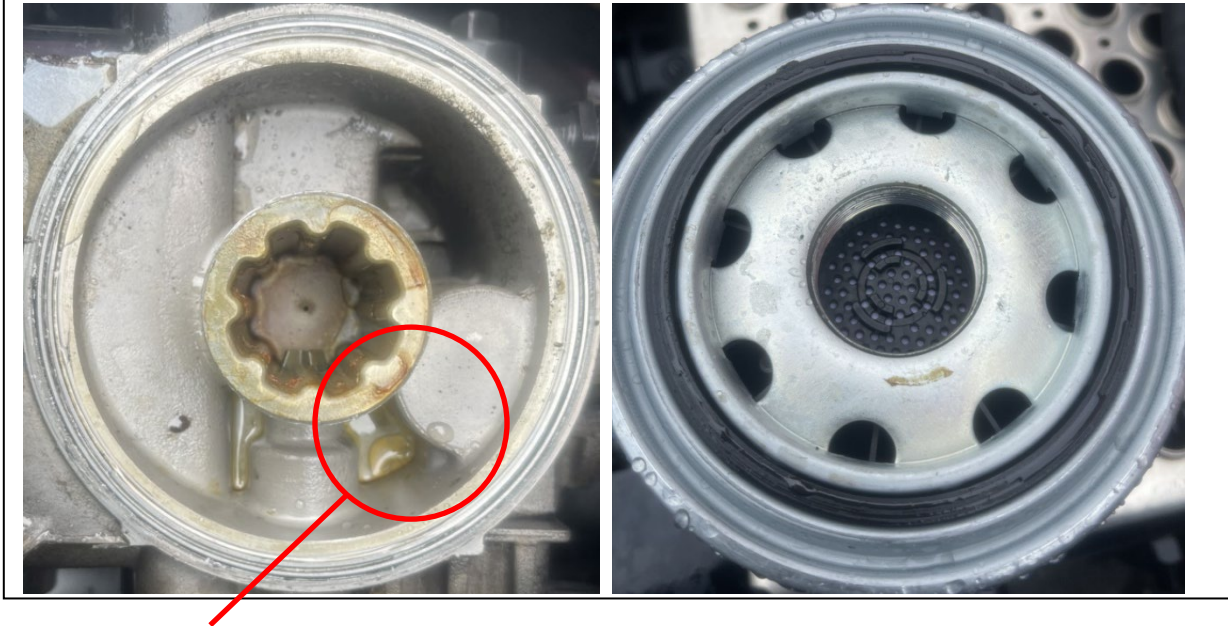
**No contamination indicated:**

**Note:** Moisture (Water) droplets found on the cartridge base is normal.

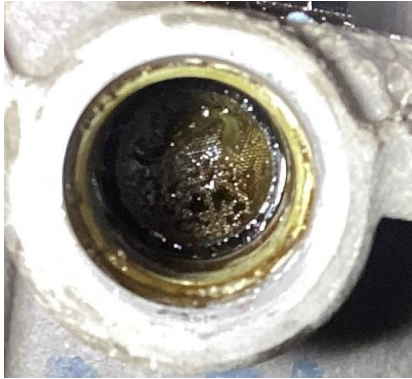
Amber Contamination and Moisture

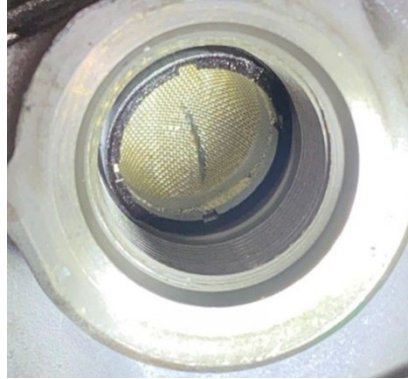
Amber Contamination

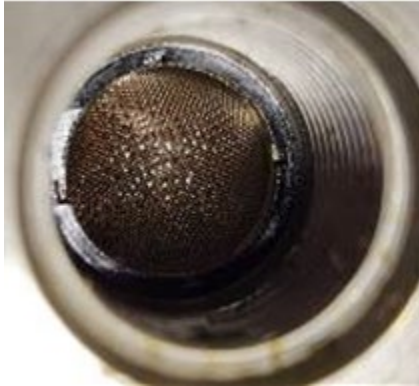
Moisture / Rust

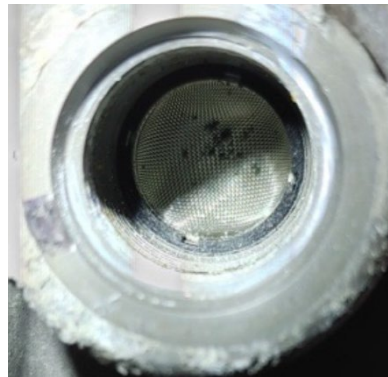
Carbon Particles

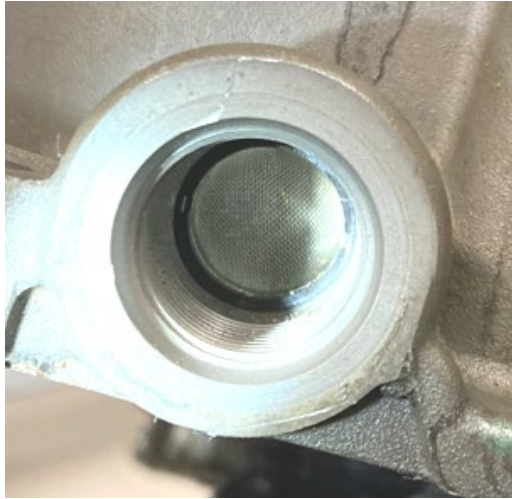
No contamination indicated

45 months in service

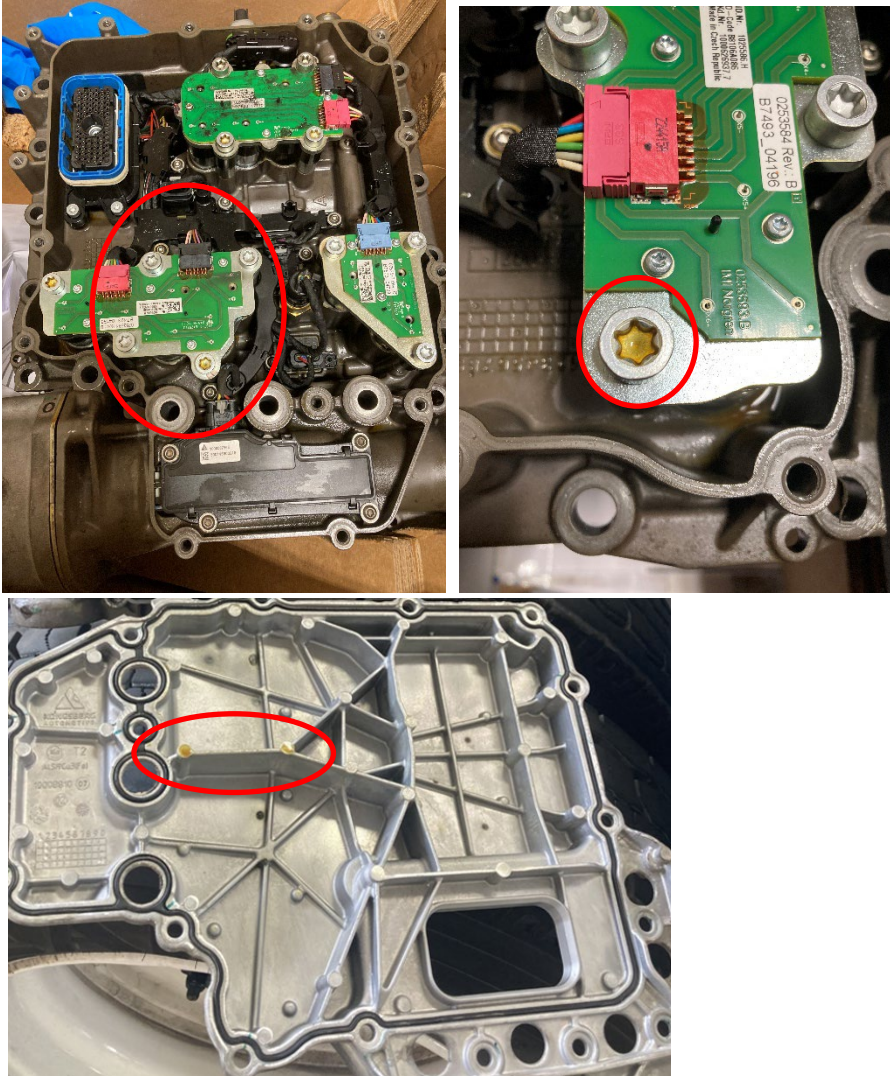
#### MTM - Non-warrantable:

- If **no** contamination is found, record findings in warranty claim, go to **Step 15**.
- If contamination is found, recording findings in warranty claim. Based on color of substance – determine next steps:
  - If **Amber\*** only substance is found, MTM fault codes are due to contamination from the vehicle air system and not a transmission product defect. Recommend MTM replacement and inspect Inertia Brake air line for Amber substance contamination – If contamination found, recommend replacement of Inertia Brake Assembly and air line (Non-Warrantable Repair). Process complete.
  - If **Black only** (beyond normal trace amounts) or **Black** (beyond normal trace amounts) and **Amber\*** substance is found, go to **Step 13**.

Amber only substance contamination:

**\*NOTICE:** Eaton Cummins Automated Transmission Technologies recommends inspection and repair of the vehicle air system to correct the source of contamination. Refer to OEM and/or vehicle air system manufacturer maintenance guidelines to ensure proper air system operation, i.e., drain water from air tanks, replace air system filters and cartridges. Refer to [Vehicle Maintenance Recommendations](#).

- Recommend MTM replacement and Inertia Brake inspection.
- Refer to OEM and repair/maintain vehicle air system.
- Refer to [Vehicle Maintenance Recommendations](#).

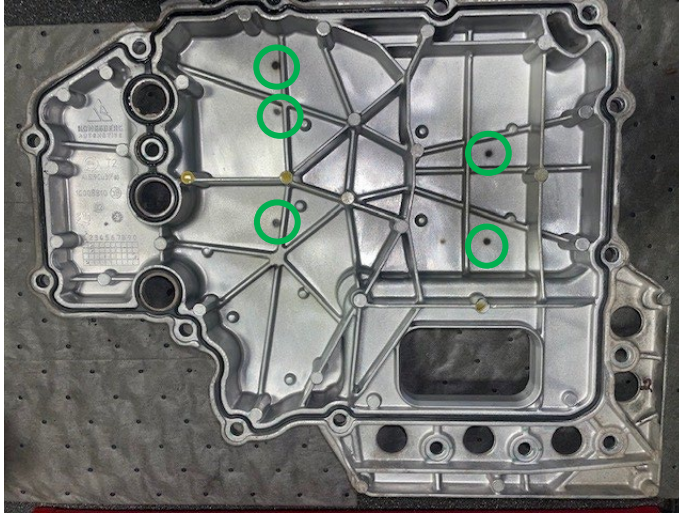
### MTM – Normal

Trace amounts of transmission oil exhausted from the valve is considered normal.

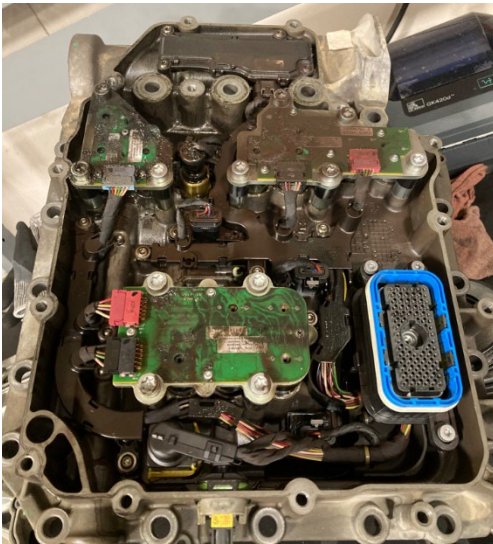
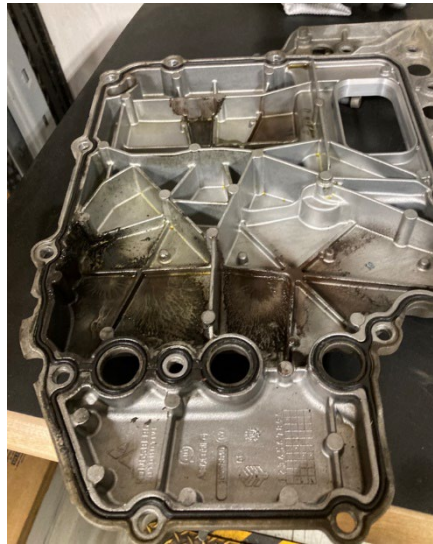
### MTM - Warrantable:

Black substance contamination:

- No contamination (Warrantable Repair):
  - MTM Kit only.
- Black only or Black and Amber substance present (Warrantable Repair):
  - If **no** Black or **no** Amber substance present in the Inertia Brake Air Line:
    - MTM Kit only.
  - If Black or Amber substance present in the Inertia Brake Airline:
    - MTM Kit
    - Inertia Brake Assembly
    - Inertia Brake Air Line.

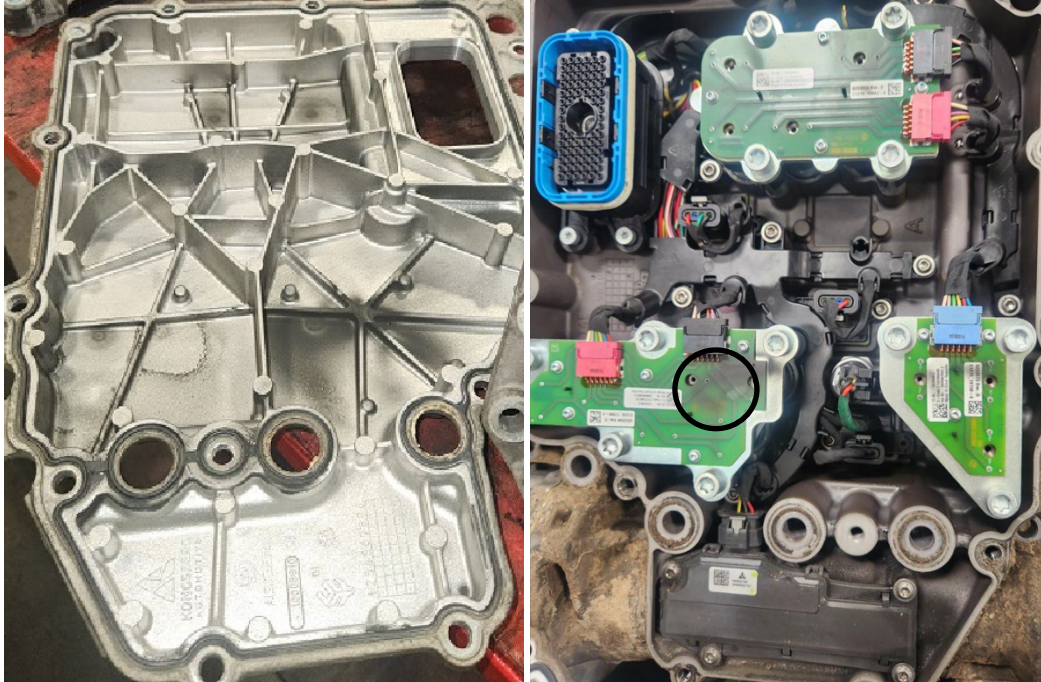
#### MTM - Warrantable

Black substance contamination:

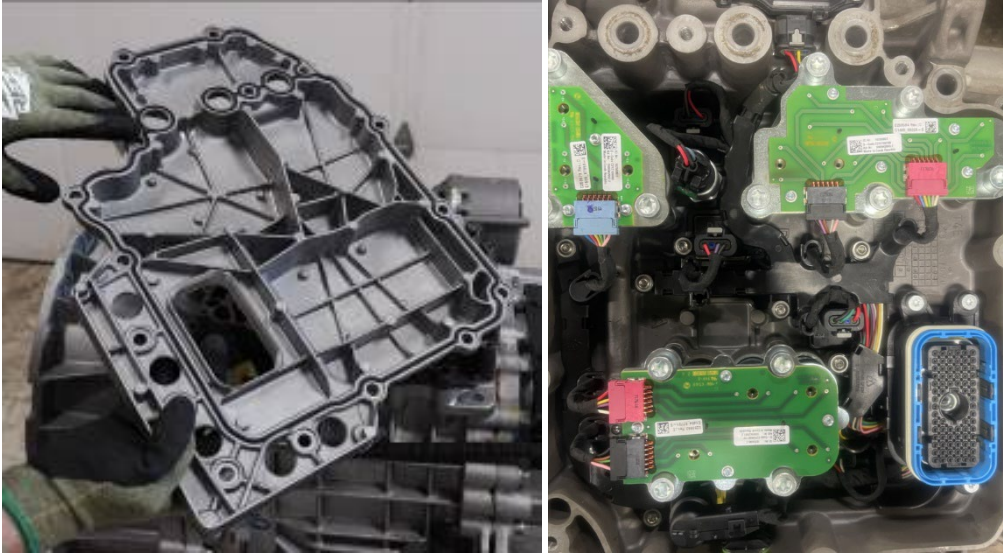
#### MTM - Warrantable

No Contamination:

**18.** Replace MTM only (Warrantable Repair).
