**Subject:** MTM Solenoid Fault Codes and Vehicle Air System Contamination – Endurant HD, XD and PACCAR TX-12, TX-18

**Document Number:** TAIB-1006

**Date:** April 6, 2023

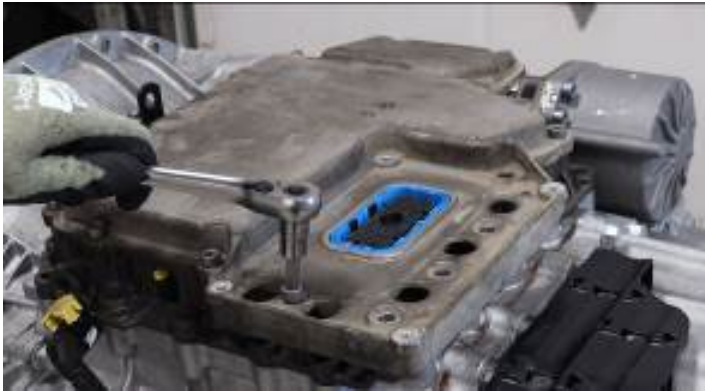
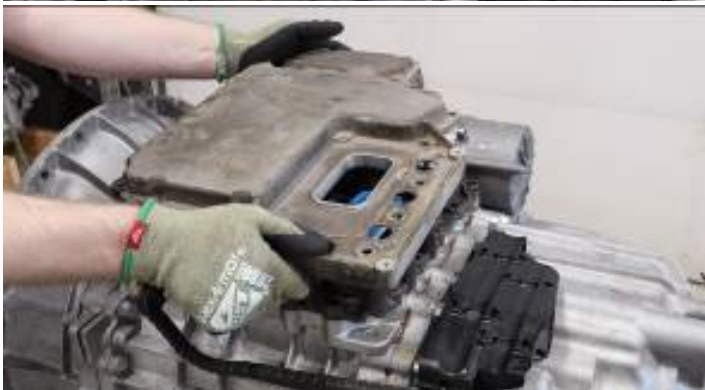
**12.** Inspect and record MTM cover and components for contamination, record color of substance(s) and compare to **MTM Cover** image examples below:

- If **no** contamination is found, record findings in warranty claim, go to **Step 15**.
- If contamination is found, recording findings in warranty claim. Based on color of substance – determine next steps:
  - If **Amber\*** only substance is found, MTM fault codes are due to contamination from the vehicle air system and not a transmission product defect. Recommend MTM replacement and inspect Inertia Brake air line for Amber substance contamination – If contamination found, recommend replacement of Inertia Brake Assembly and air line (Non-Warrantable Repair). Process complete.
  - If **Black only** (beyond normal trace amounts) or **Black** (beyond normal trace amounts) and **Amber\*** substance is found, go to **Step 13**.

**\*NOTICE:** Eaton Cummins Automated Transmission Technologies recommends inspection and repair of the vehicle air system to correct the source of contamination. Refer to OEM and/or vehicle air system manufacturer maintenance guidelines to ensure proper air system operation, i.e., drain water from air tanks, replace air system filters and cartridges. Refer to [Vehicle Maintenance Recommendations](#).

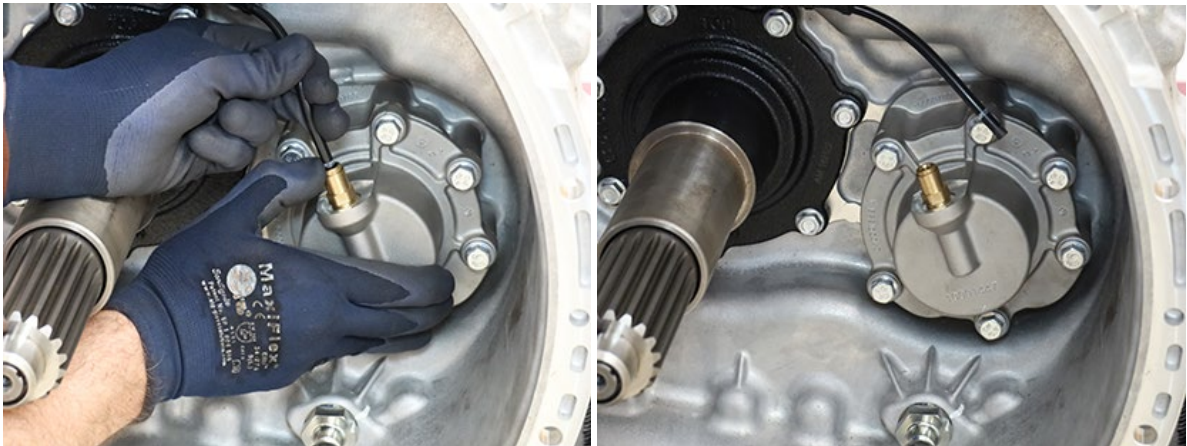
14. Inspect Inertia Brake Air Line and fitting for Black and Amber substance.

- If Black or Amber substance present, recording findings in warranty claim, and replace: MTM, Inertia Brake Assembly and Inertia Brake Air Line (Warrantable Repair).

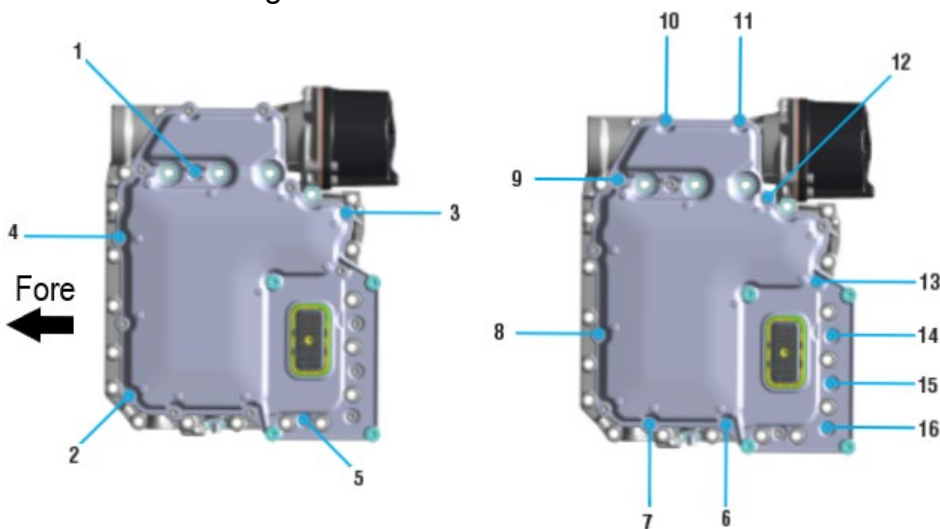
**CAUTION:** Follow the MTM Cover cap screw torque specification and sequence as shown. Failure to follow torque specification and sequence may damage MTM Housing, Cover and O-ring.

**17.** Torque MTM Cover cap screws 1 through 5 and 6 through 16 to 23–27 Nm (17-19 ft-lb) as shown in the torque sequence below.
