**Subject:** ServiceRanger 4 Connection Settings – Add Profile

**Document Number:** MDIB-0051

To ensure Eaton® ServiceRanger 4 connectivity with a Transmission Electronic Control Unit (TECU) and Transmission Control Module (TCM) a proper connection settings profile is required.

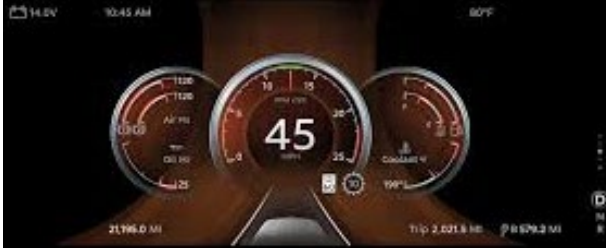
- Vehicles equipped with a full digital display (dash) are equipped with a VECU, example below:

\*The following may assist in determining if vehicle is equipped with a Vehicle Electronic Control Unit (VECU):

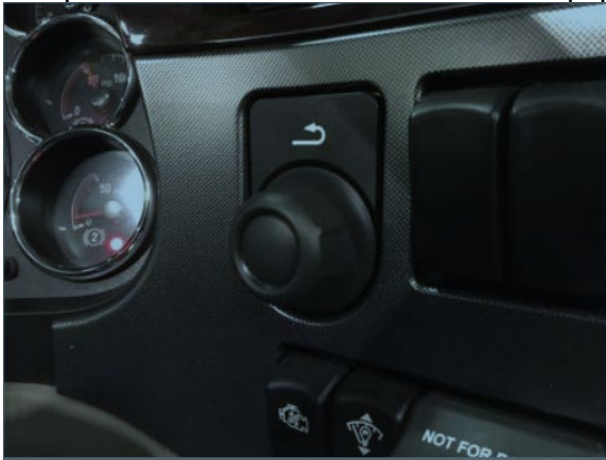
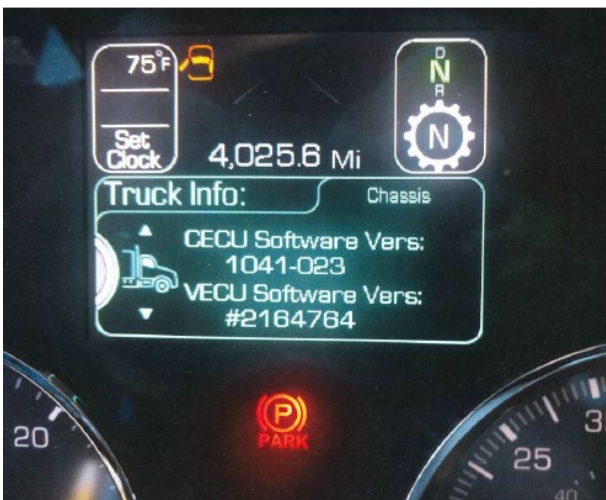
- Vehicles equipped with analog gauges and a digital display – Use digital display push-scroll dial, go to Truck Info, Chassis tab, scroll through list of components to determine if vehicle is equipped with a VECU or not:
